Sprint Case Study

3M Rises to the Challenge— No Crane Necessary

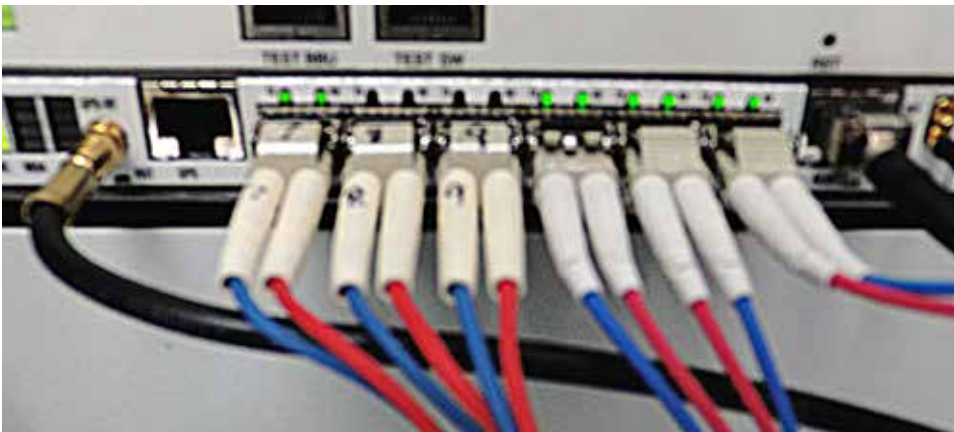
Backup Battery Unit (BBU) with link lights out prior to fiber restoration

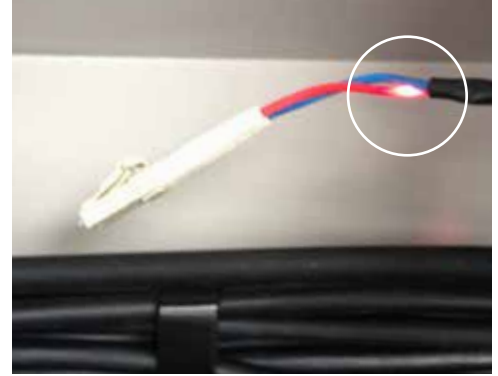
When Sprint's managed services provider investigated the signal loss, it was discovered that someone had purposefully broken into the junction box at the base of the cell site and used pliers to crimp and break 19 fiber connections in an effort to disrupt Sprint cell service. The associated fiber cables ran all the way up to the radio heads as part of three hybrid power/fiber cables, which sat atop a 100-foot chimney tower. The vandal was successful. Sprint's signal in the area was degraded or nonexistent. Sprint customers in the area—and those traveling through—had limited or nonexistent cell service.

Damaged fiber with visible light leakage at crimp point

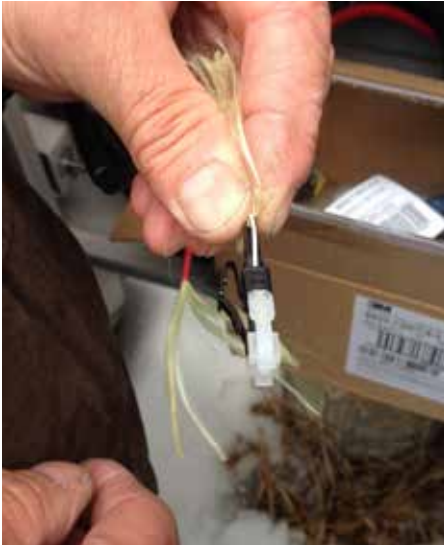
Fiber prepped and ready for mechanical splice actuation

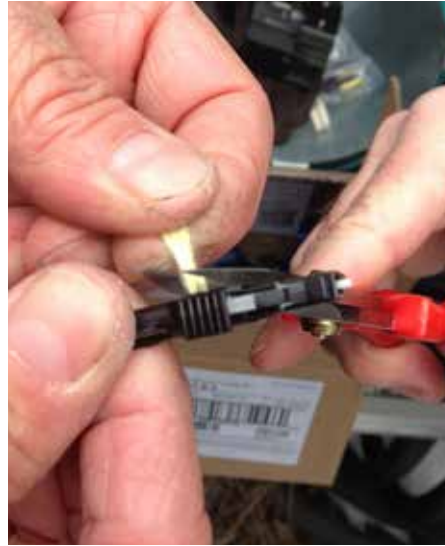
Aramid strength member captured by connector boot strain relief mechanism

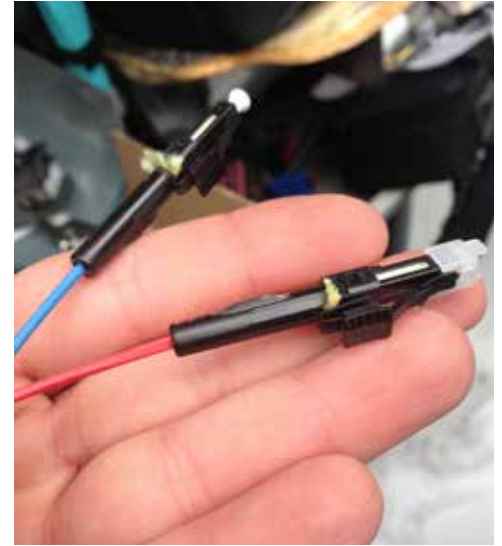
Repaired fibers terminated with 3M™ No Polish Connectors

The 3M No Polish Connector enables fast, field installation of 250 μm , 900 μm , and jacketed singlemode and multimode connections with its one-piece, pre-assembled design.

This high-performance connector is LC-compatible and features a built-in, factory-polished ferrule assembly and a mechanical splice 3M is known for and has installed hundreds of thousands of times all over the globe. It can be quickly and easily installed with common fiber prep tools and the 3M™ Easy Cleaver. This cleaver is disposable after 120 uses, unlike blade-style fiber cleavers that require a significant capital investment to equip installation and maintenance crews.

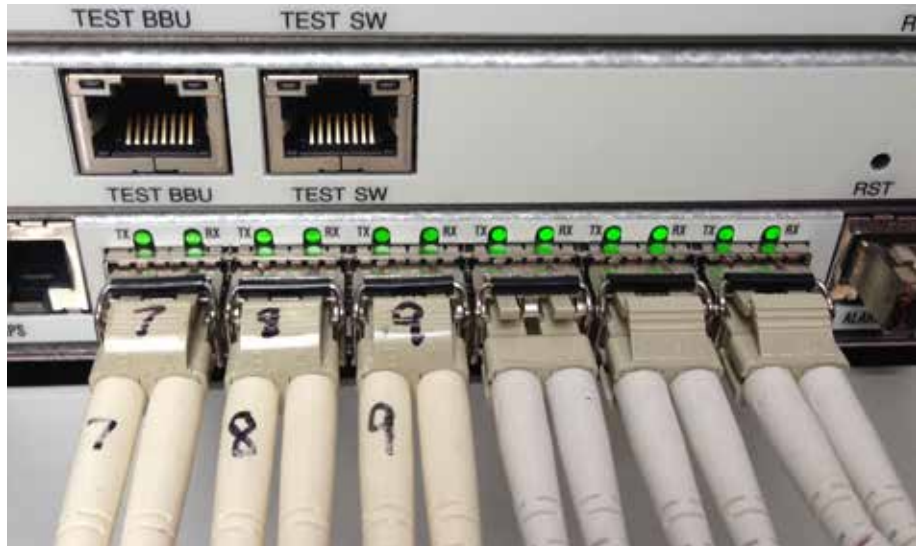
Backup Battery Unit (BBU) with link lights restored after fiber repair

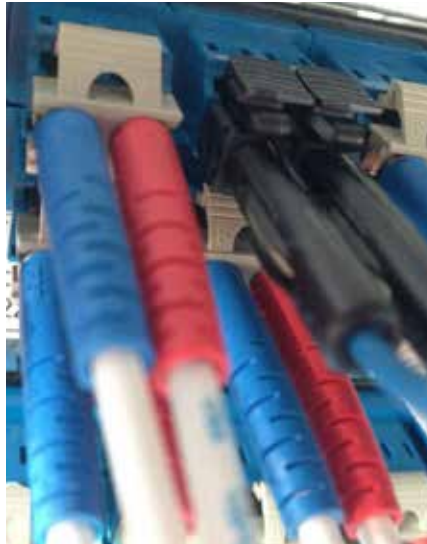
Repaired fibers in junction box enabling optical link restoration
